**Re: C and R Recyclers
Notice of Violation (NOV)
NOV
RCRA C - Hazardous Waste
Williams County
OHR000218552**

Subject: Complaint #250429125724_WEC, FCI, Notice of Violation

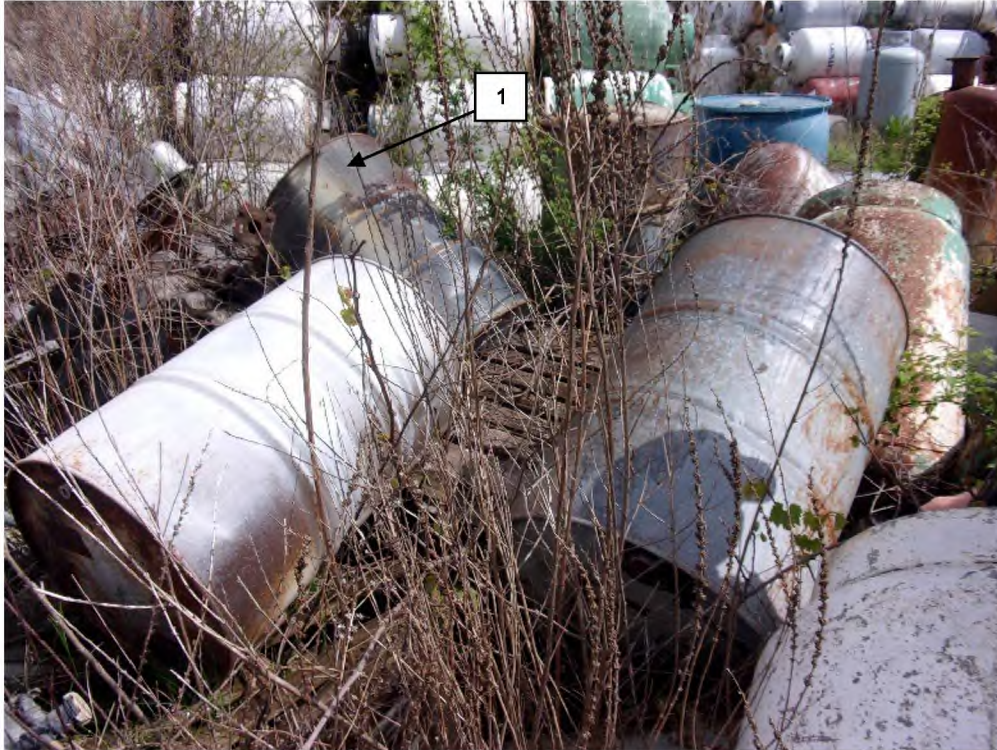
- a. C & R Recyclers failed to determine if the waste inside a 55-gallon drum located in the southeast corner of the property is a hazardous waste (Image 1, labeled #1). During the inspection, the drum was unlabeled, the drum was lying sideways in brush vegetation, and C & R Recyclers were unable to identify the contents.

Image 1. Gray drum full of unknown contents in the pile of propane tanks and drums

In order to resolve the violations, Ohio EPA recommends that C & R Recyclers immediately evaluate these wastes to determine if they are hazardous waste as required by this rule and submit the evaluations to this office for review.

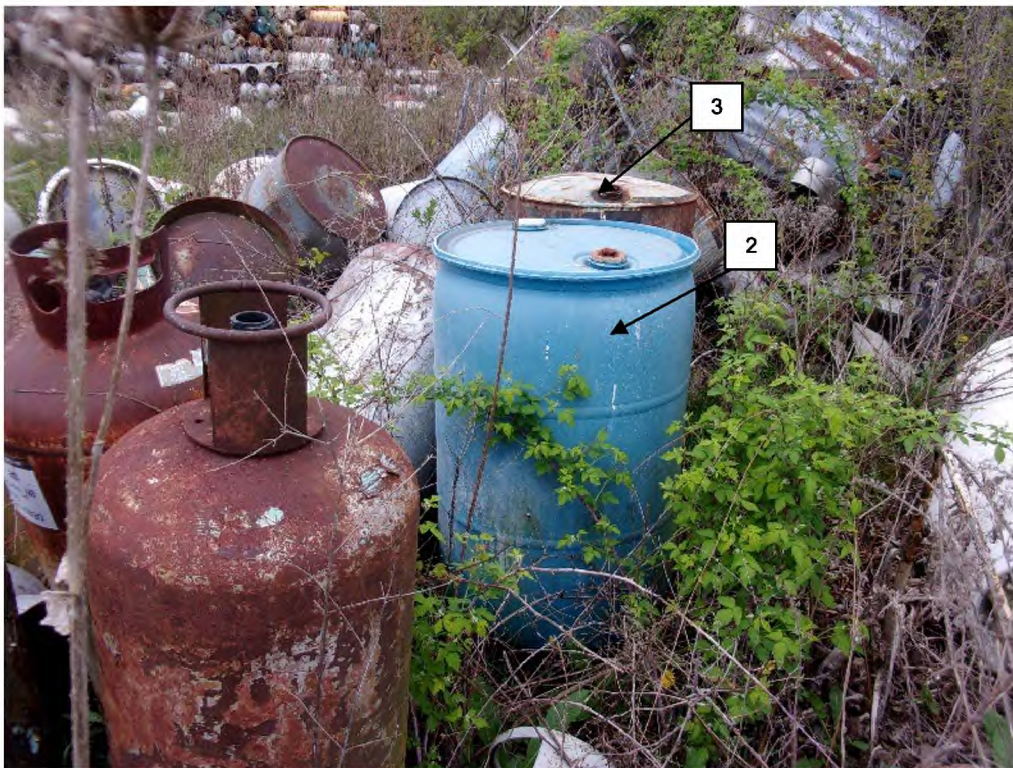
- b. C & R Recyclers failed to determine if the waste inside a 55-gallon blue poly drum located in the southeast corner of the property is a hazardous waste (Image 2, labeled #2). During the inspection, the drum was unlabeled, and C & R Recyclers were unable to identify the contents.

- c. C & R Recyclers failed to determine if the waste inside a 55-gallon drum located in the southeast corner of the property is a hazardous waste (Image 2, labeled #3). During the inspection, the drum was unlabeled, the condition of the drum was rusting and bulging, and C & R Recyclers were unable to identify the contents.

Image 2. Blue poly drum and bulging rusted drum in propane tank and drum pile

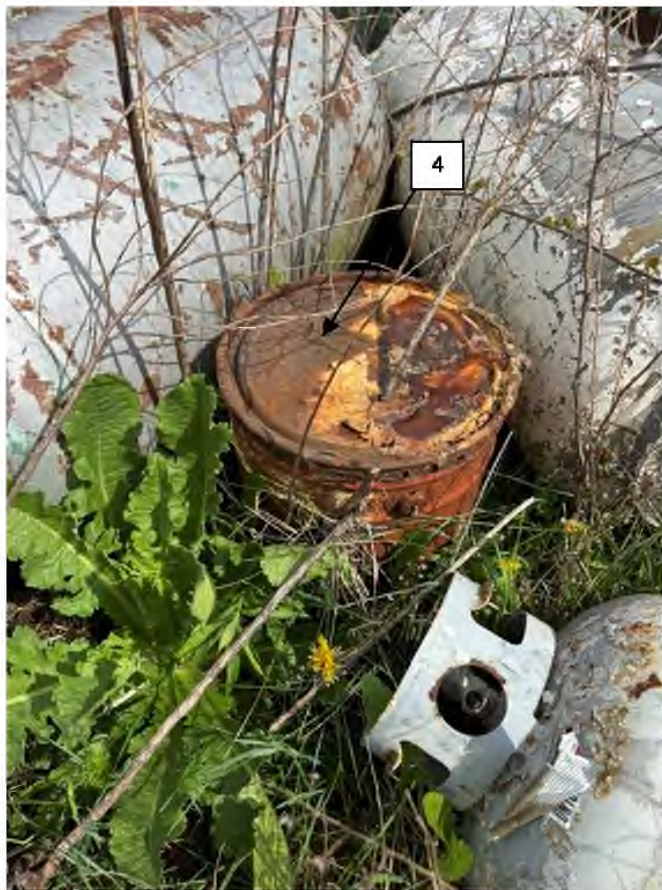
- d. C & R Recyclers failed to determine if the waste inside a 5-gallon bucket located in the southeast corner of the property is a hazardous waste (Image 3, labeled #4). During the inspection, the container was unlabeled, rusting and in poor condition, and C & R Recyclers was unable to identify the contents.

Image 3. Rusting 5-gallon bucket in propane tank and drum pile

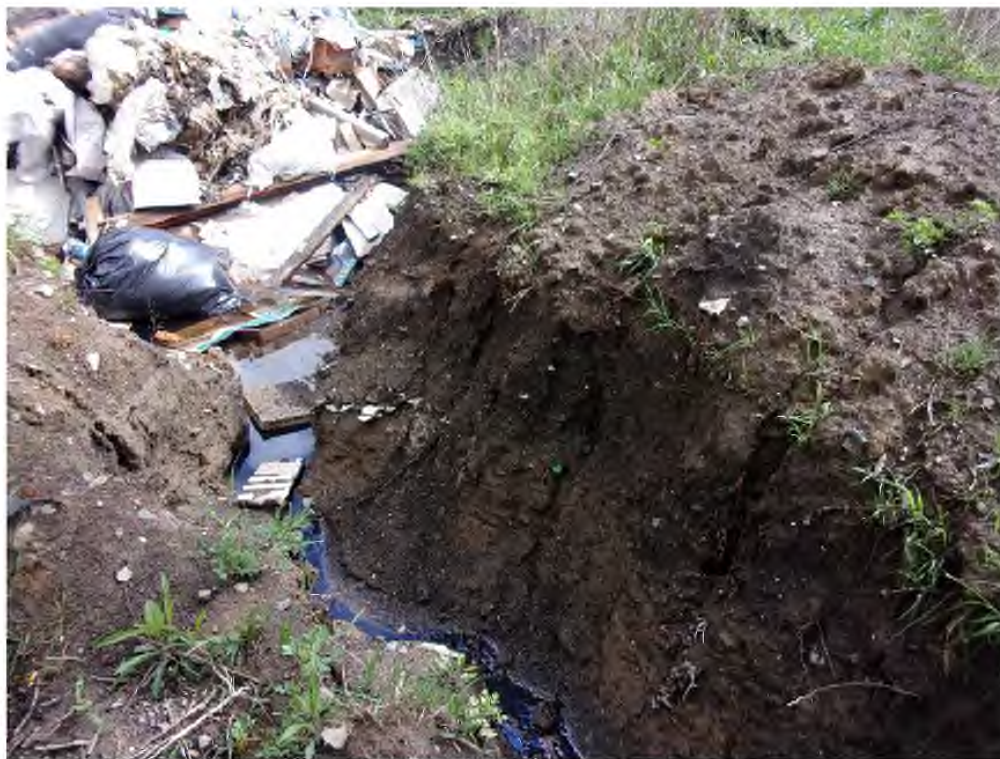
- e. C & R Recyclers failed to determine if the liquid flowing from the trash pile in the southwest corner of the property is a hazardous waste (Images 4 and 5). During the inspection, a dark liquid with a sheen was flowing from the trash pile in the southwest corner of the property. C & R Recyclers were unable to identify the liquid flowing from the trash pile.

Image 4. Dark liquid flowing from trash pile

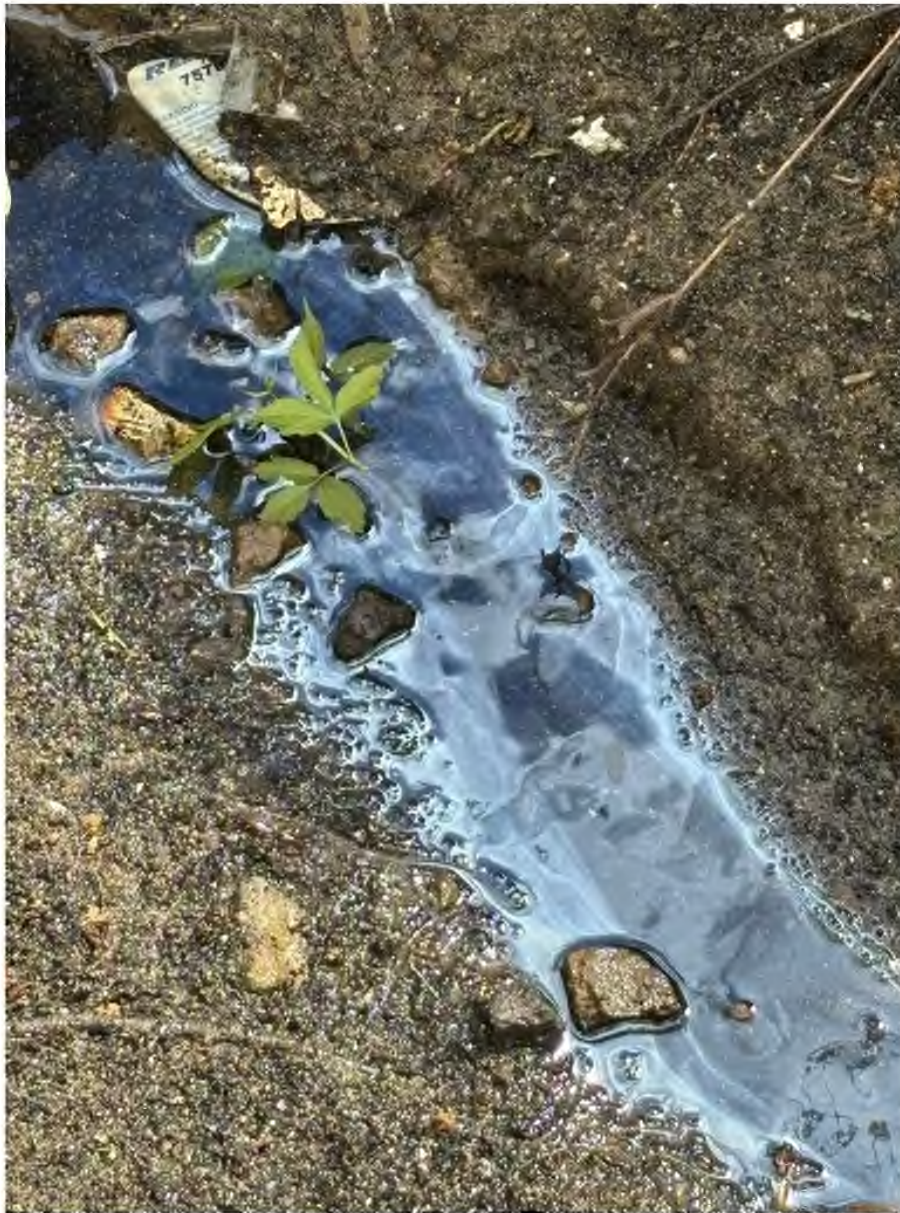
Image 5. Sheen of the dark liquid flowing from the trash pile
